## Historic, archived document

Grays Harbor, Wn.

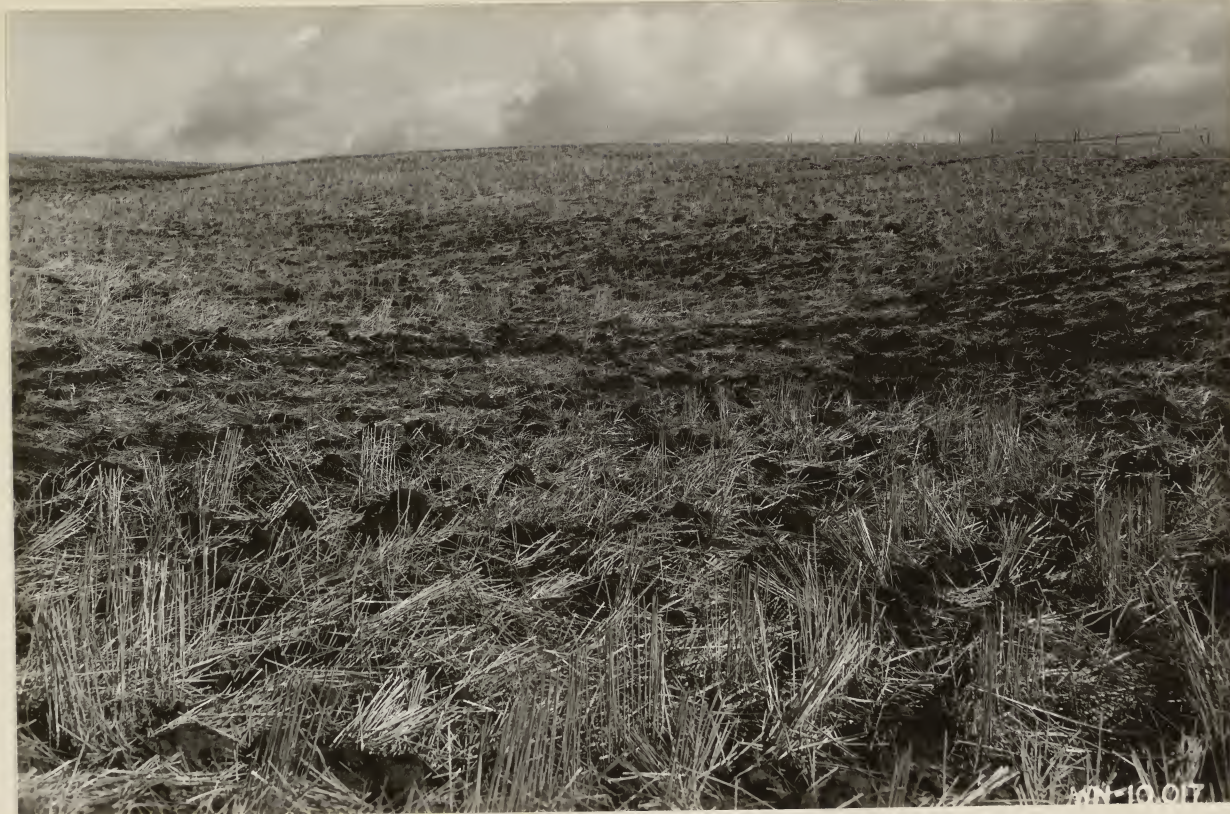
WN-10017. Washington.  
FARMING.

This field was fall chiseled. Chiseling is a rough tillage method designed to control run-off and give better moisture penetration due to the incorporation of crop residues. No sign of run-off was apparent in this field after a three-inch rain which occurred in January. Compare this field with those shown in WN-10016 and WN-10018.

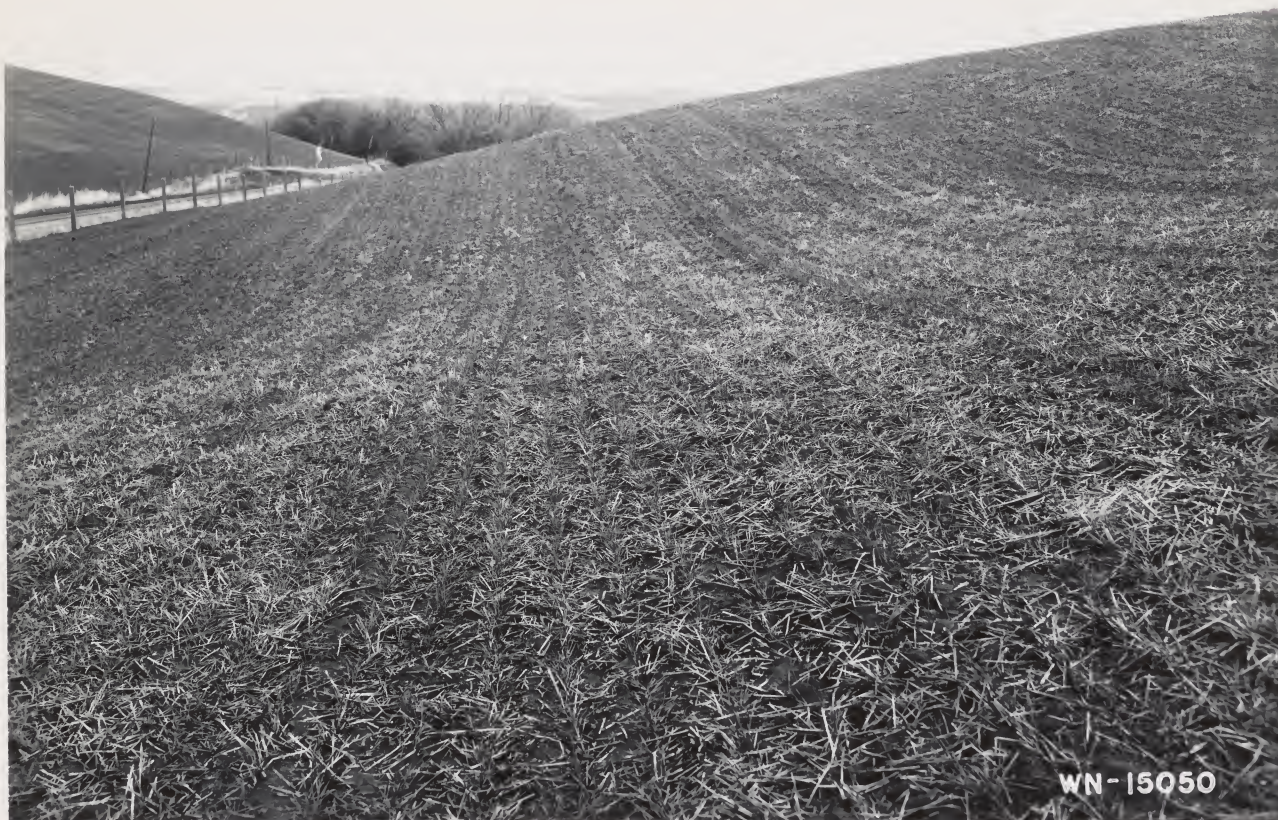
Wn-15050

Winter wheat on straw-mulch type of trashy fallow. Practically no loss of soil is indicated. Compare with Wn-15051. Mayview silt loam. Oscar Victor, owner-operator, 21 miles northeast of Pomeroy, Washington.

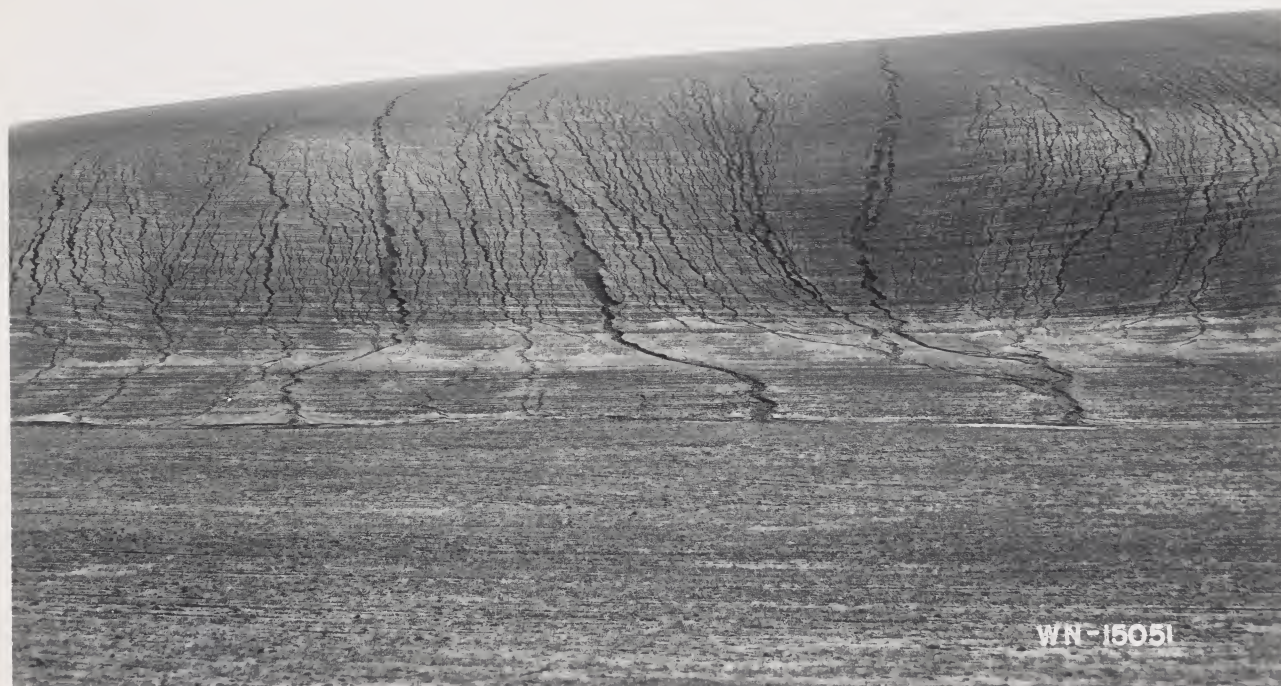
Wn-15051

Severe erosion due to lack of surface protection. Field plowed with moldboard plow following winter wheat crop. Summer fallowed in 1939 and planted to winter wheat. 8.3 tons per acre soil loss. Mayview silt loam. Roy Kimball, owner-operator, 21 miles northeast of Pomeroy, Washington.

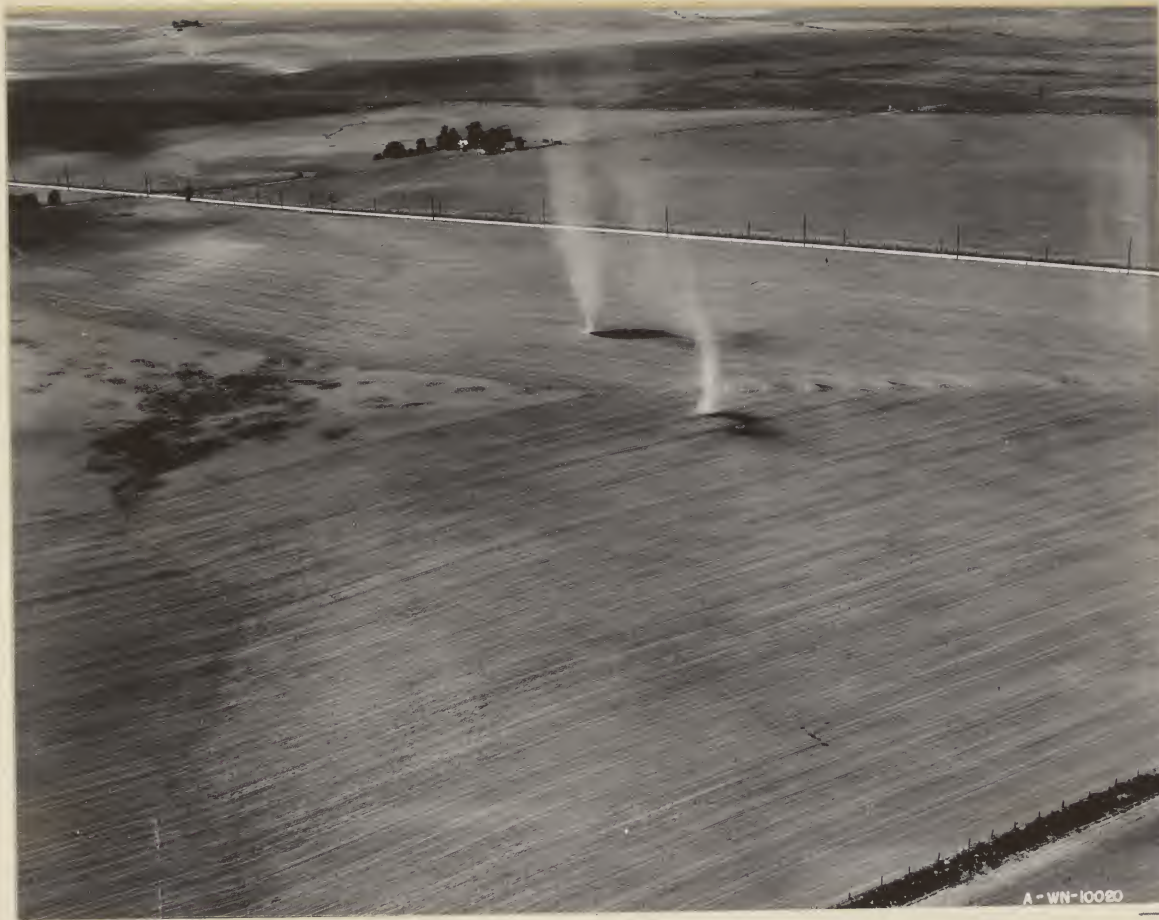
A-WN-10,020

Whirlwinds in finely-tilled summer fallow. This field is badly infested with morning glory. The weeding operations have pulverized the soil finely, aggravating wind erosion. Although fairly flat this land blows readily. Cornwall Estate operated by Wm. Vollmer, Walla Walla County, Washington.

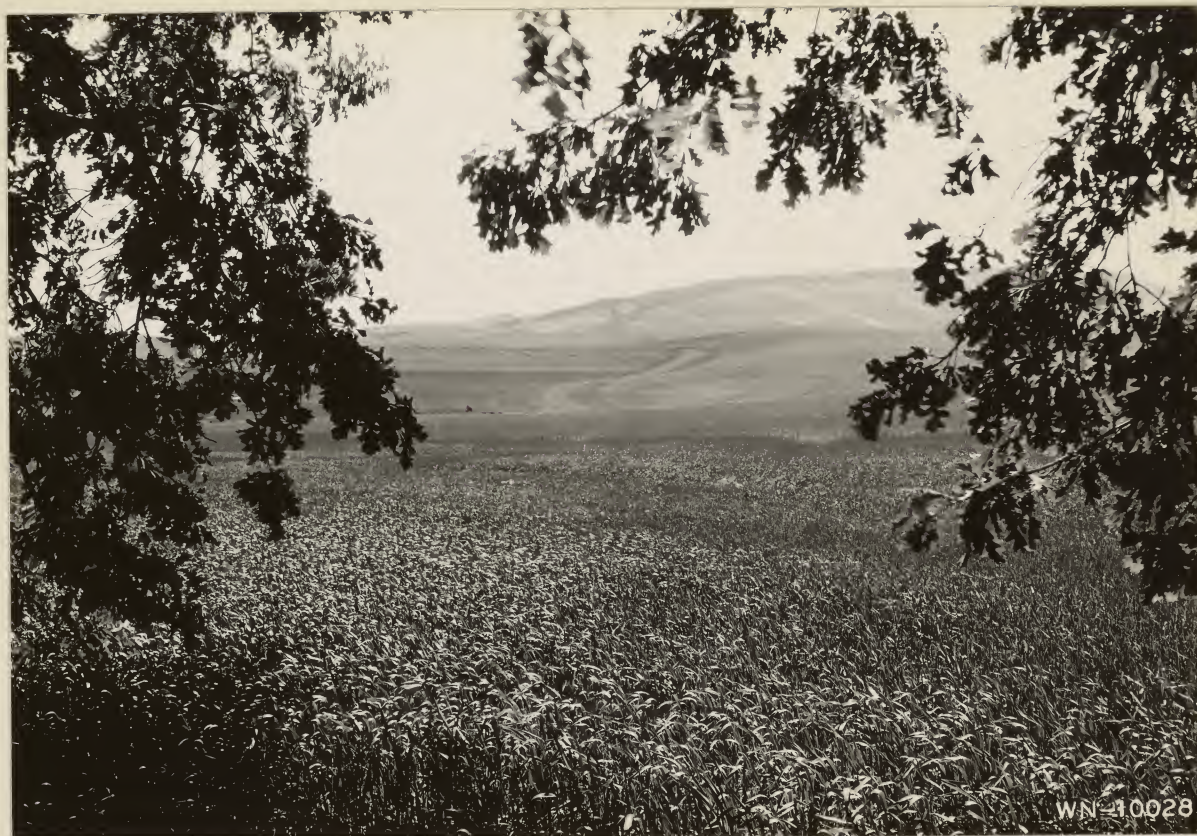
Wn-10,028. Washington.  
EROSION CONTROL - Gully Control.

In the foreground is shown a field of spring wheat; in the background a field of summer-fallow. Note the gully which has been filled and seeded to a grass-alfalfa mixture. Delbert Barger farm, six miles east of Walla Walla, Walla Walla County. June 18, 1936,

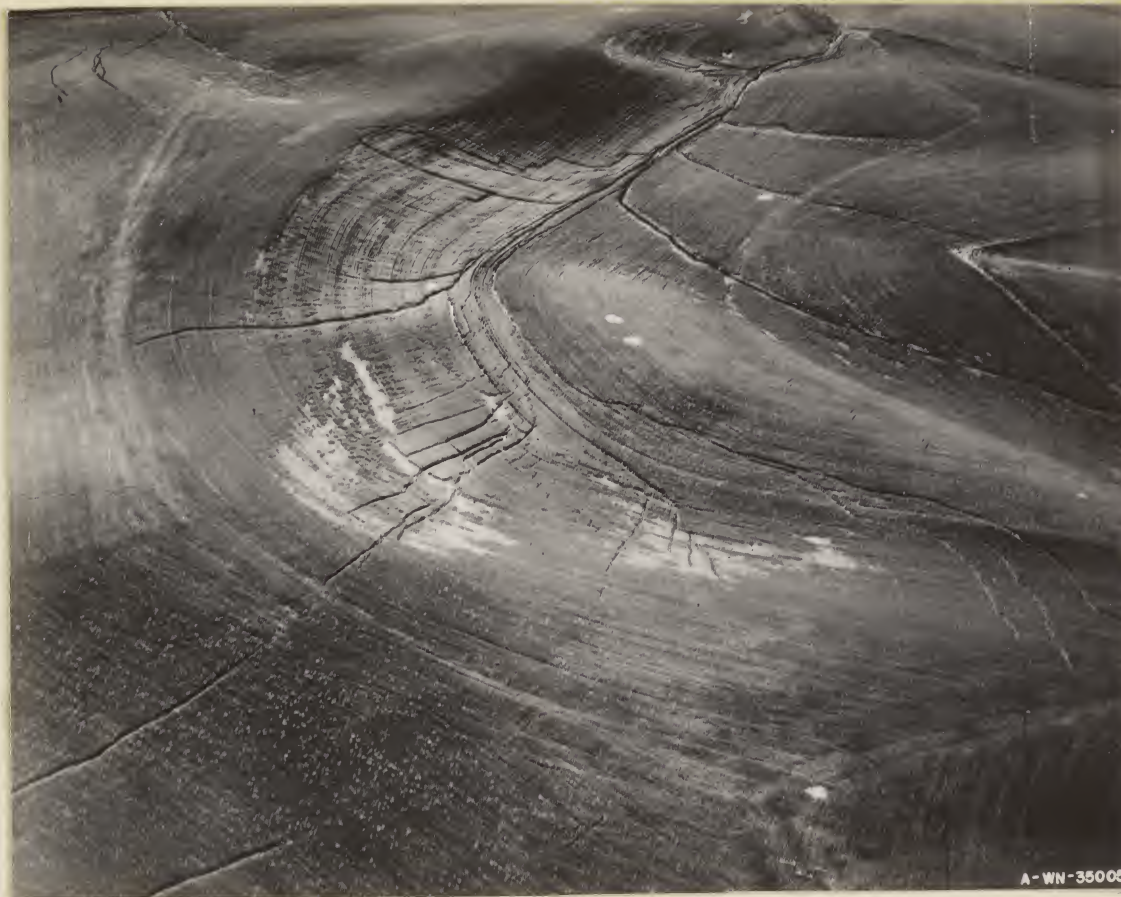
A-WN-35,005

Sheet erosion on north and east slopes seeded to spring wheat. Four miles southwest of Waitsburg, Washington.

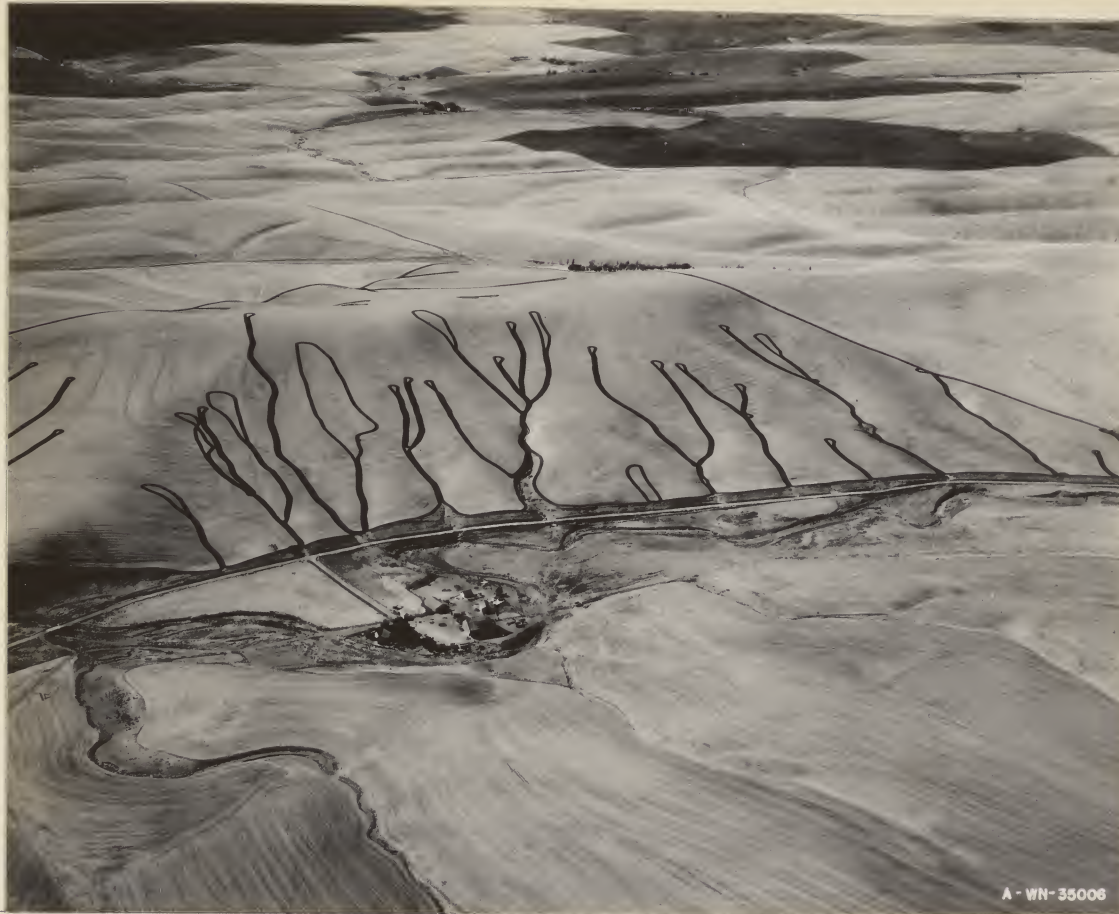
A-WN-35,006

Following the harvest season, the farmer has worked this field by plowing in the gullies and leaving the loose soil in gully bottoms without seeding. or using any other method of control to prevent the wash of this loose soil from his field. This photograph was taken five miles north of Central Ferry, Washington, and is a typical example of the farm method used by many farmers in this area.

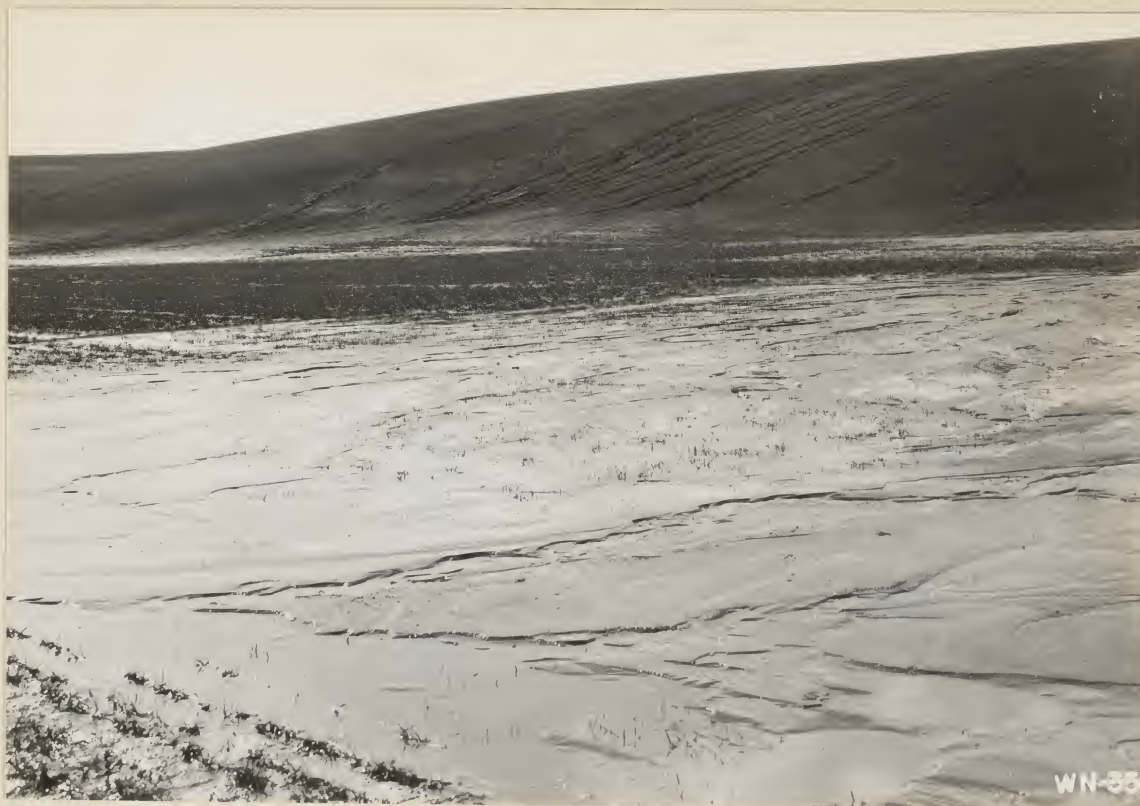
WN-35,007. March 3, 1936. Incipient gullying to plow sole and severe muddy inundation in a fine tilled summer fallowed field. Mellinger farm near Seltice Station, south of Tekoa, Whitman county, Washington. Mr. Mellinger said that this field had been cultivated throughout the summer (in fact, seventy-two or seventy-five times) in an effort to control noxious weeds. The ground was therefore pulverized to a fine ashy condition before being seeded to winter wheat late in the fall. The entire broad hilltop to the right of the picture has intermittent clay outcrops. The ten or fifteen acre hilltop, even though relatively level, presented a network of anastomosing, tiny, clay-cut and clay-filled channels. The larger incipient washes shown back center were cut from the run-off from this relatively level hilltop. Where drill rows ran up and down the slope, each disc track had been cut to plow sole. Mr. Mellinger is now starting a program of crop rotations over his 400-acre farm by dividing it into five or six fields and using a six-year rotation involving legumes.

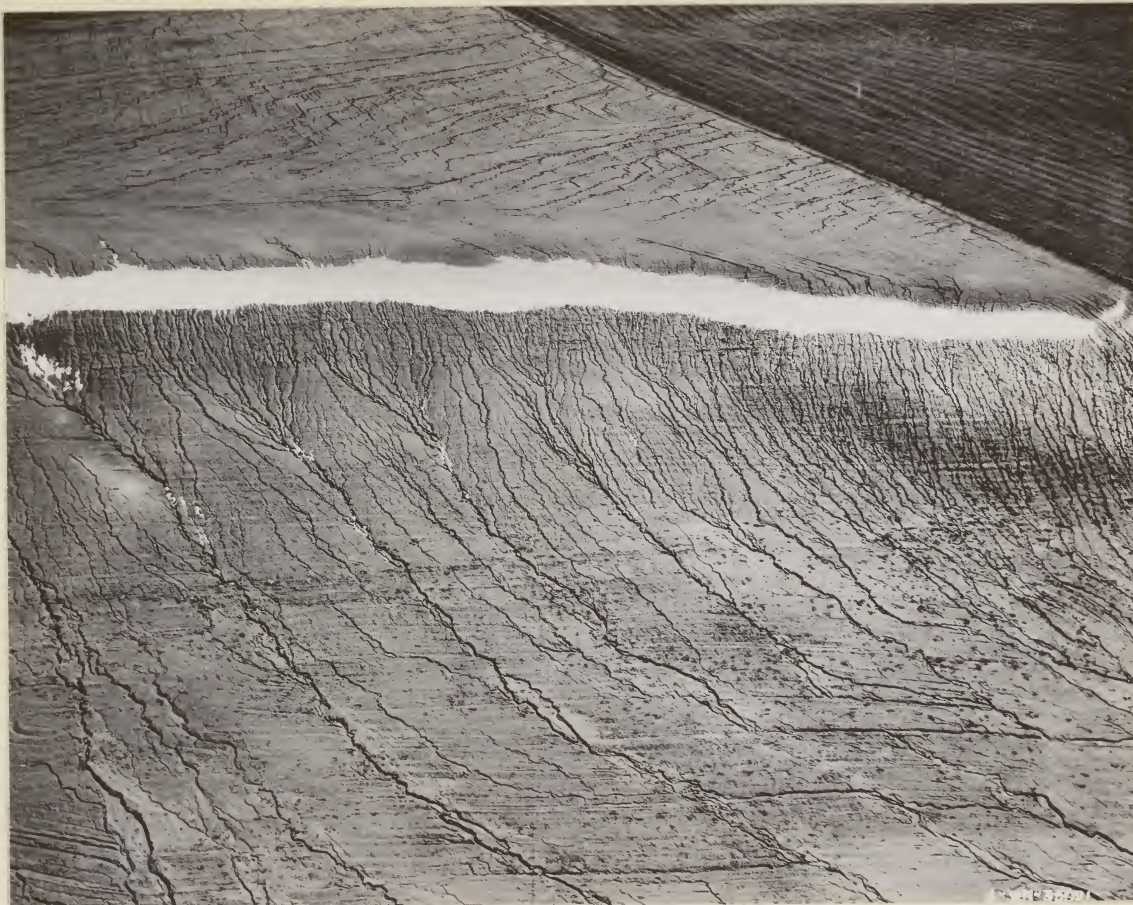
A-WN-35021

Davenport-Wilbur proposed work area. Sheet and gully erosion on sloping agricultural lands. This erosion caused by rains and melting snow is increasing as the organic matter and fertility of the soil are lowered by erosion and cropping. Location: 5 miles northeast of Bluestem, Washington.

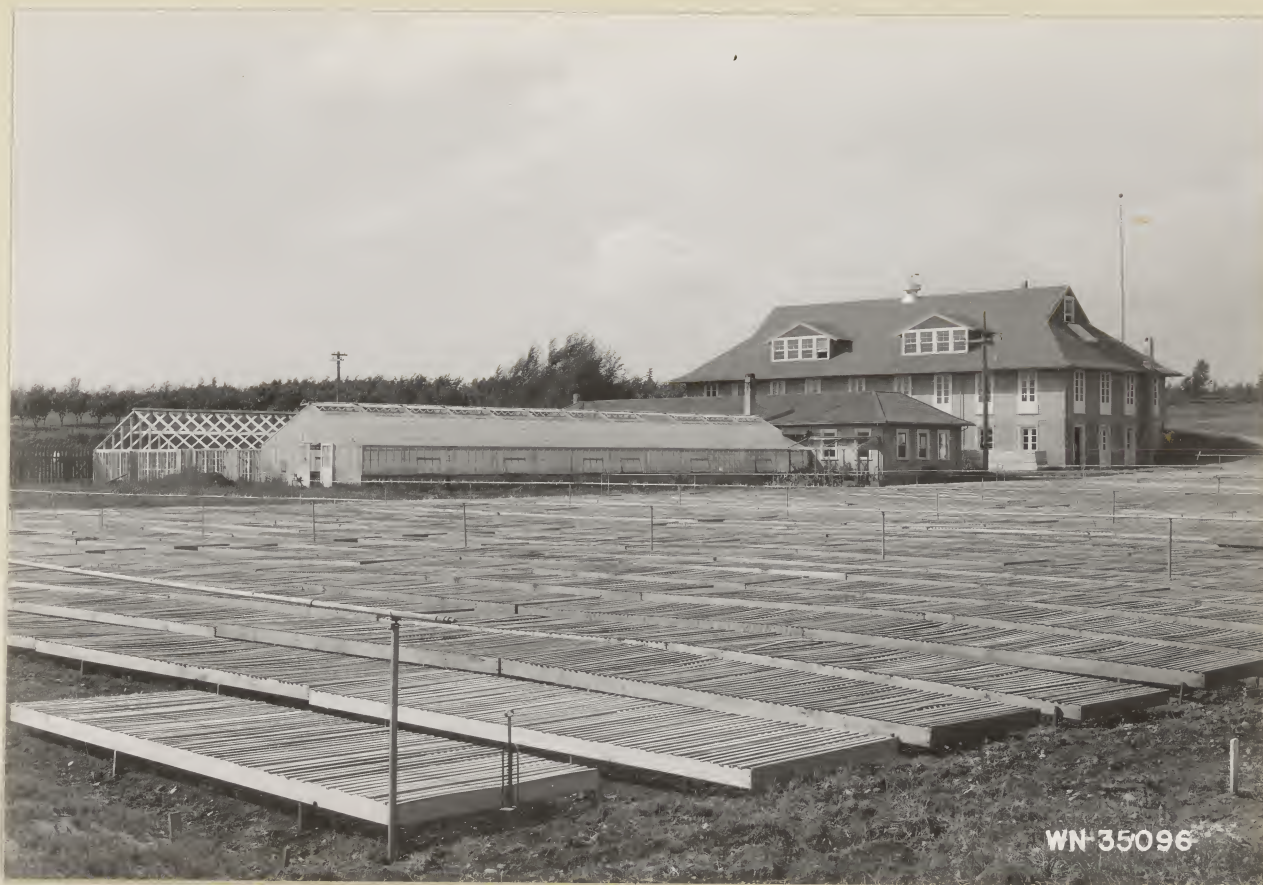
WN-35096. Whatcom County, Washington; August 22, 1936.

A view of the coniferous seed beds at the Bellingham, Washington, nursery, Section of Nurseries, Soil Conservation Service, Region 11. This photograph shows approximately 80% of the area devoted to seed beds in 1936. Note the over-head sprinkling system and the shade frames used to cover the seed beds. Approximately 12,000,000 seedlings are being produced in the beds shown. In the background is the greenhouse, plant shelter, hot house, and seed house.

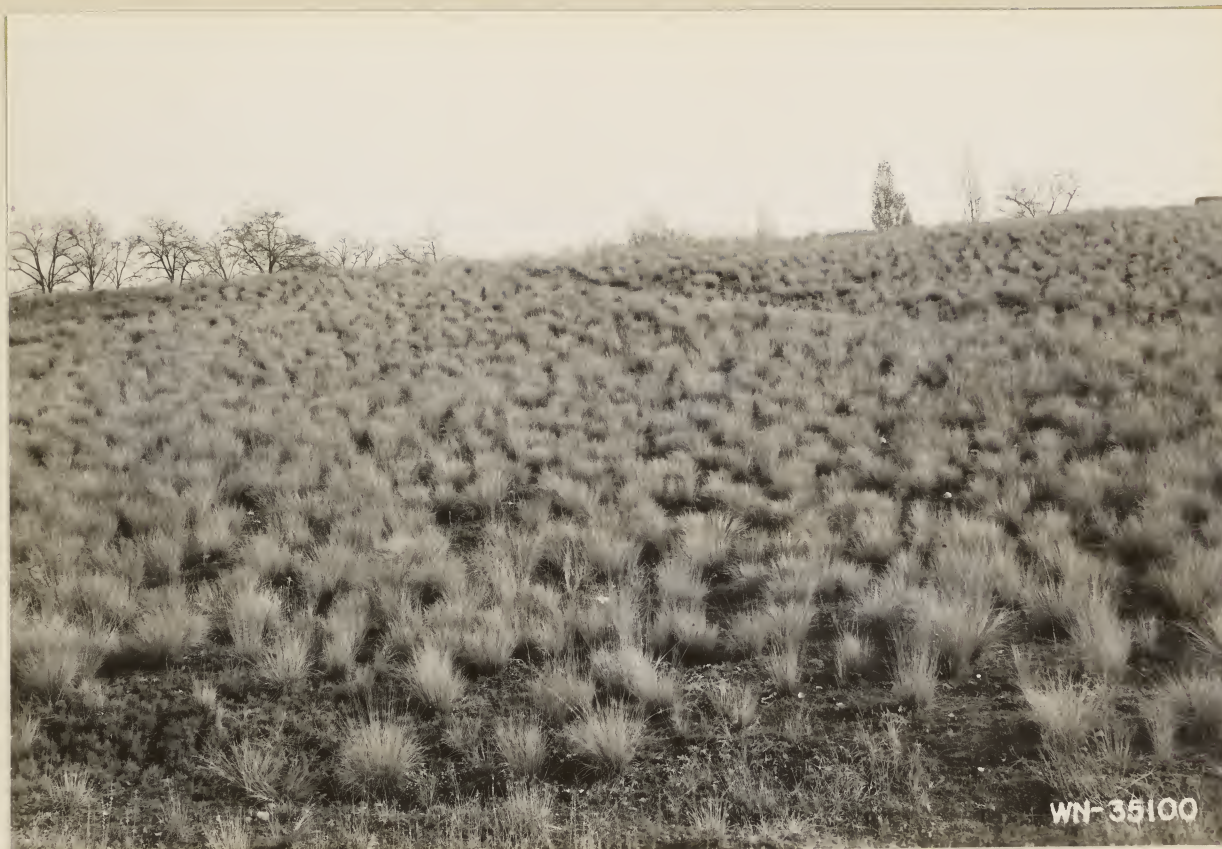
Wn-35,100. Washington.  
CROPS - Grass.

Picture showing a stand of native bunchgrass within the city limits of  
Spokane, Washington. The average height of this grass is about 18 inches.  
Spokane County. November 5, 1936. Photo by J. G. James.

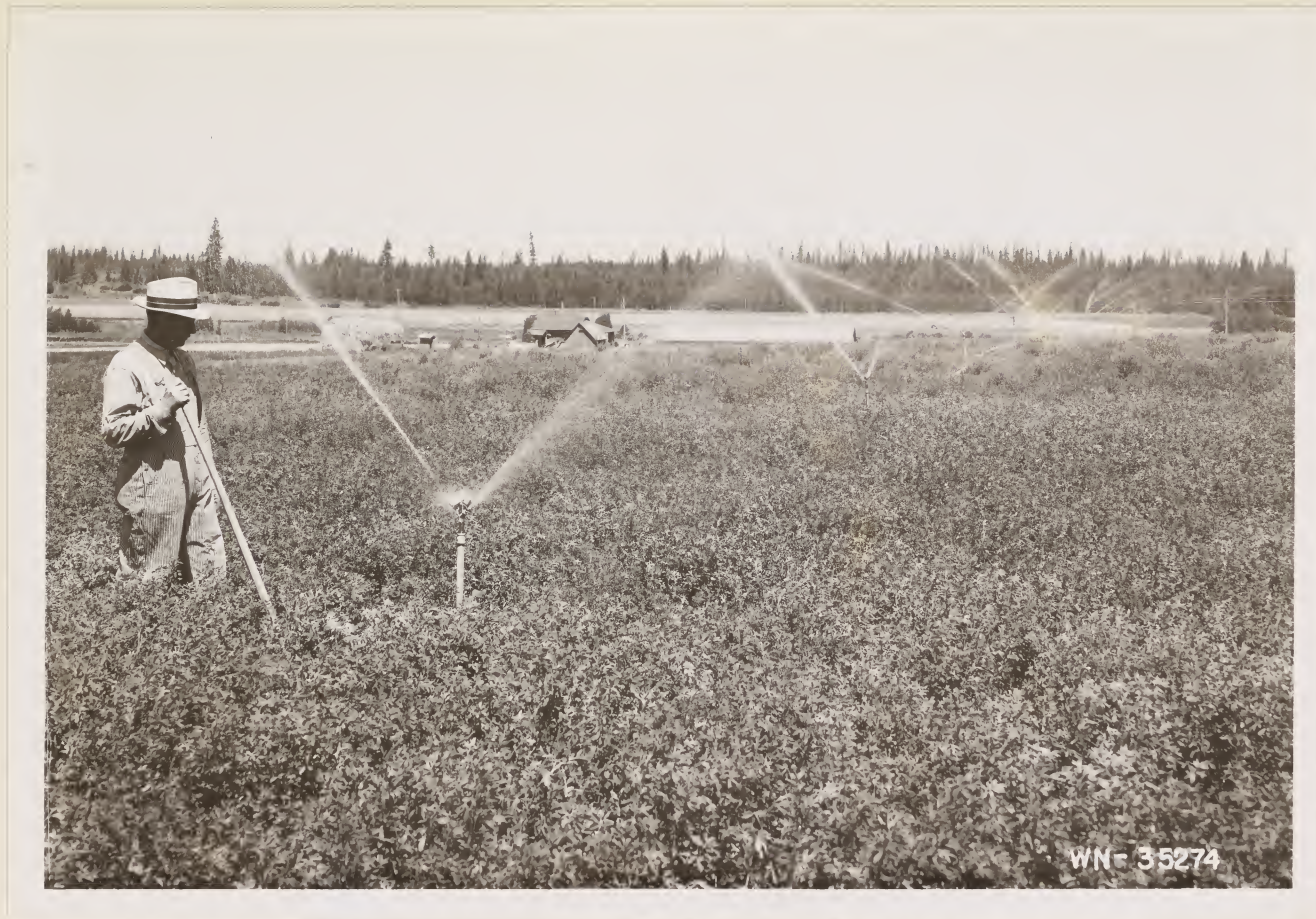
Wn-35,274                      Spokane County                      10-21-39  
Portable sprinkler irrigation system for Ezra A. Eickmeyer, 5 miles south of  
Deer Park, Washington, installed under the Water Facilities program. He is  
shown here examining one of the 15 hammer-head sprinklers operating in his dry  
alfalfa field. His farmstead is seen in center background.

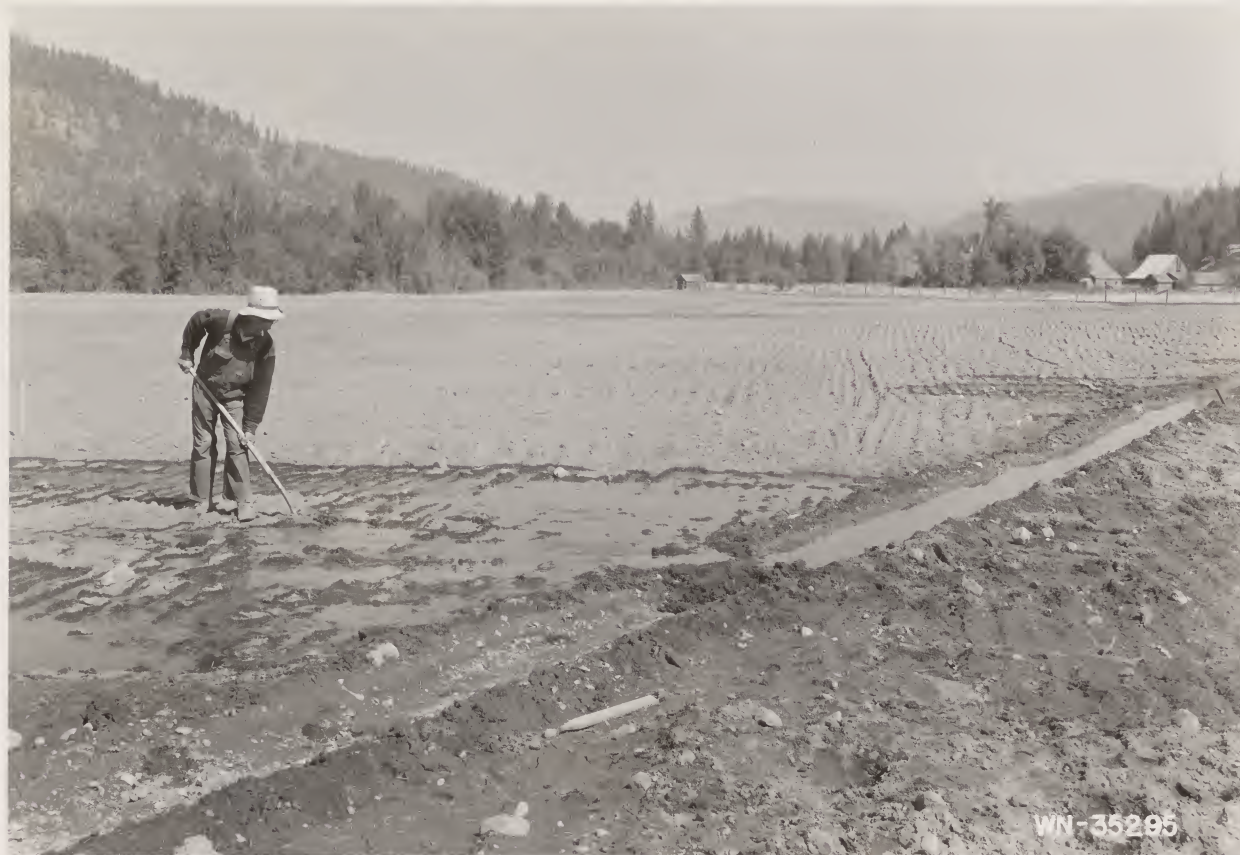
Wn-35,295

Field seeded to fall wheat wheat being irrigated by newly constructed border irrigation system, on Stephen H. Ross farm, six miles north of Chewelah. Mr. Ross is seen removing earthly material to permit an even distribution of flow over border strip. This is the first year that irrigation practices have been in operation on this field.

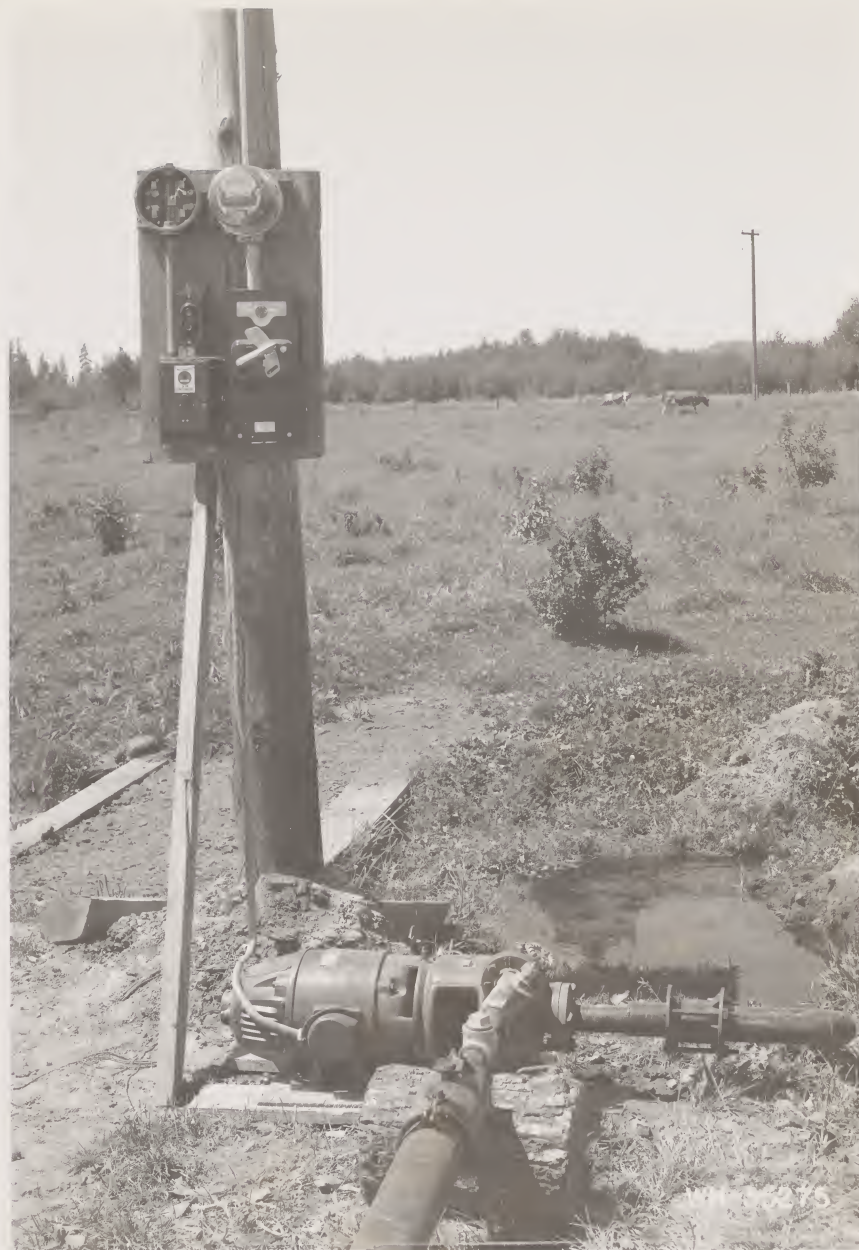
Wn-35,275      Spokane County      10-21-39  
Electric pumping unit for portable sprinkler  
irrigation system of Ezra A. Eickmeyer, Deer  
Park, Washington, installed under the water  
facility program. The compact 5 H. P. "close-  
cupld" centrifugal pump and electric motor  
unit capable of delivering 100 gallons per  
minute, is shown in center foreground and the  
control panel in upper left-hand corner.

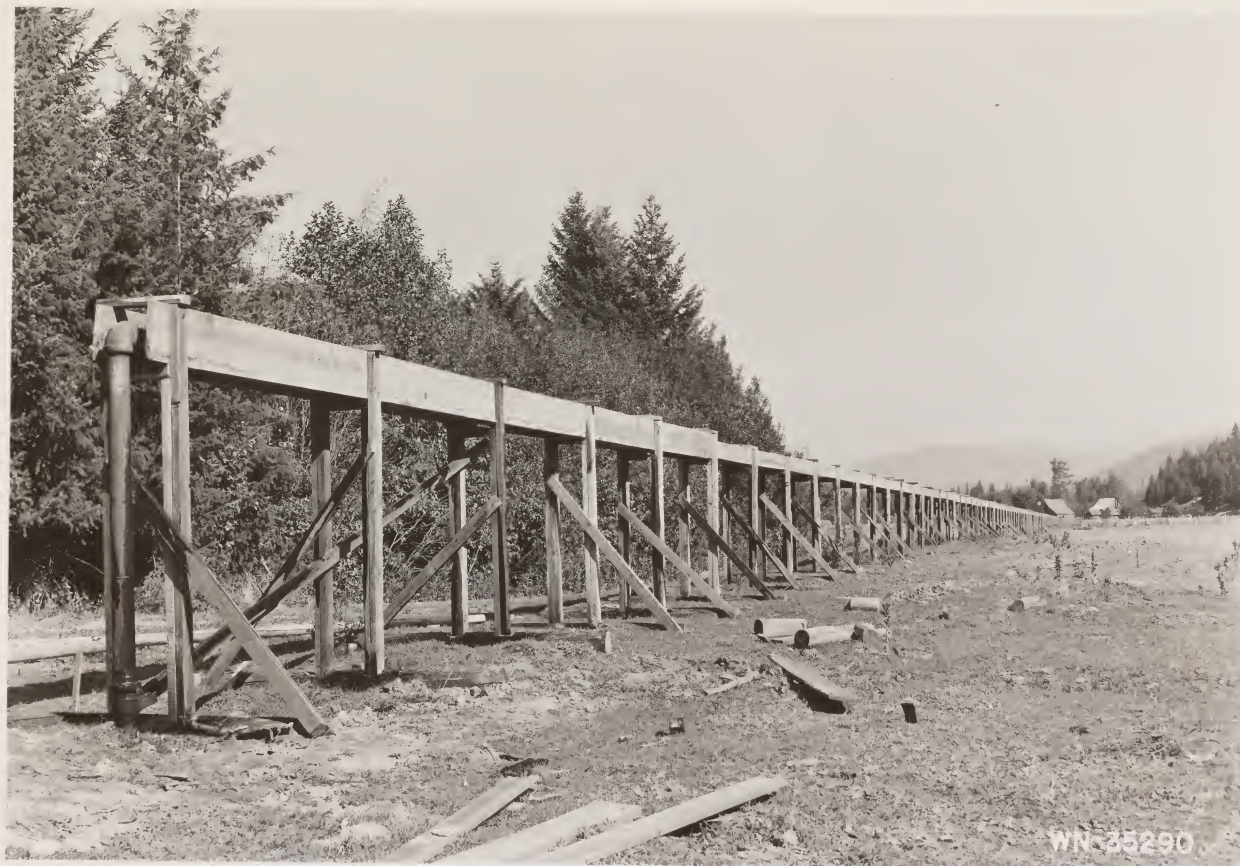
Wn-35,290

Stephen H. Ross, Cooperator, six miles north of Chewelah, Washington. Wooden flume for transporting water from pipe system to irrigable lands seeded to fall wheat and alfalfa with companion crop of smooth brome and crested wheat. This was installed under the Water Facilities program during the summer of 1939.

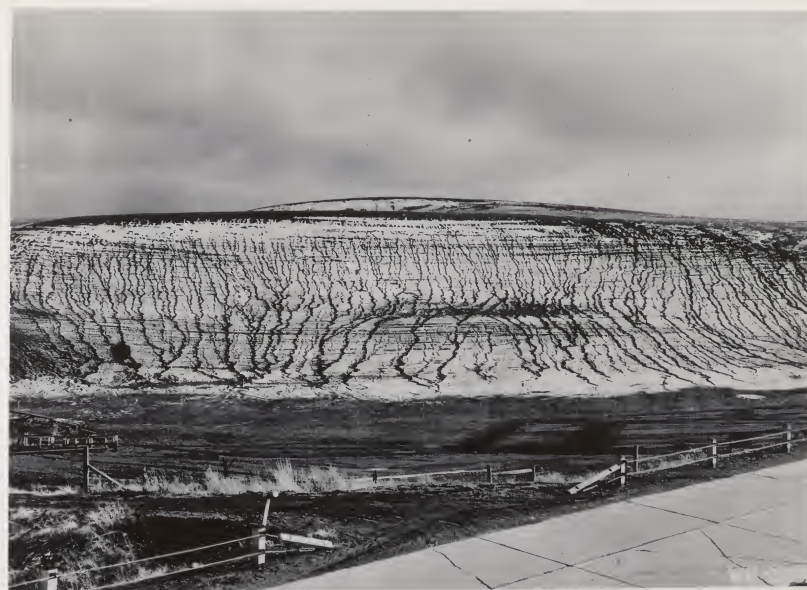
Wn-35,311      Whitman County      2-14-40  
Roadside silt deposition. Such deposits averaged 12 tons to mile along road between Moscow, Idaho and Spangle, Washington in the Spring of 1940. 1 mi N of Rosalia, Washington.

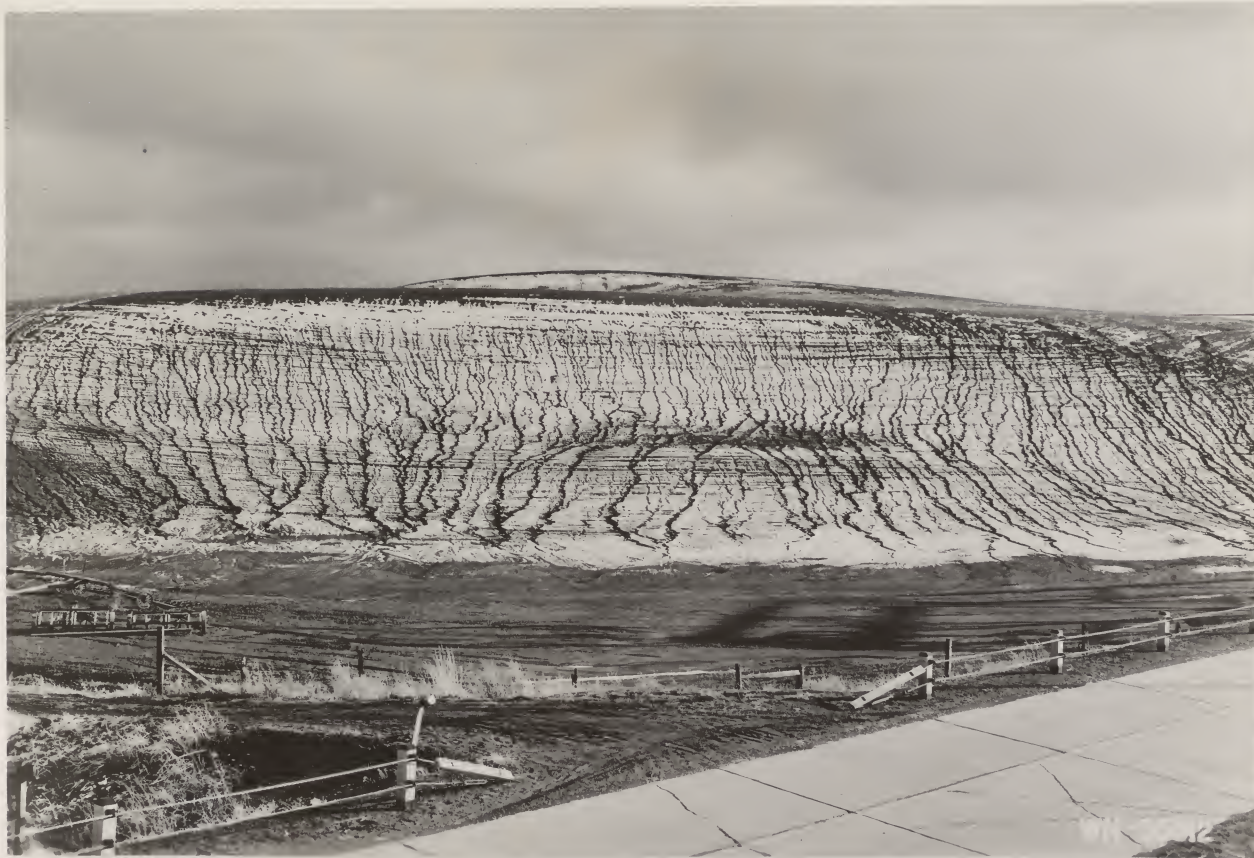
Wn-35,312

Sheet erosion highly contrasted by light snowfall remaining on north slope of this summer fallow field. Several days of heavy rainfall had riddled this field to an average rill depth of six inches.

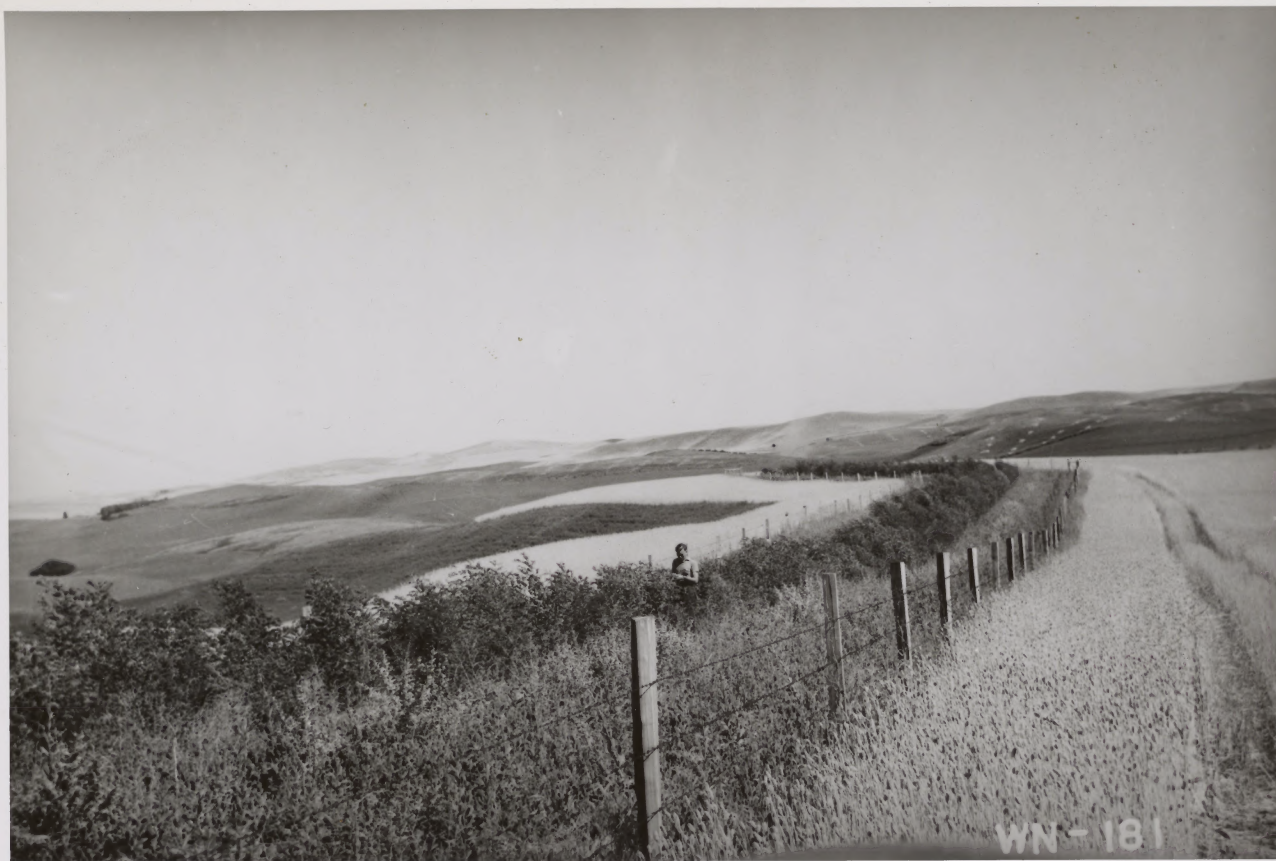
WN-181

A shelterbelt on a typical Palouse hilltop which consists of a long gently sloping south slope and a comparatively short steep north slope. Planting this shelterbelt well away from the steep north slope will assure deposition of snow on top of the ridge rather than on the north slope.
